**Flood Control Project Maintenance
Levee Inspections**
LMA District Cover Sheet
Spring 2011 Levee Inspection Results

Reclamation District No. 0817 Carlin

Levee Inspection Report By Mile - Spring 2011

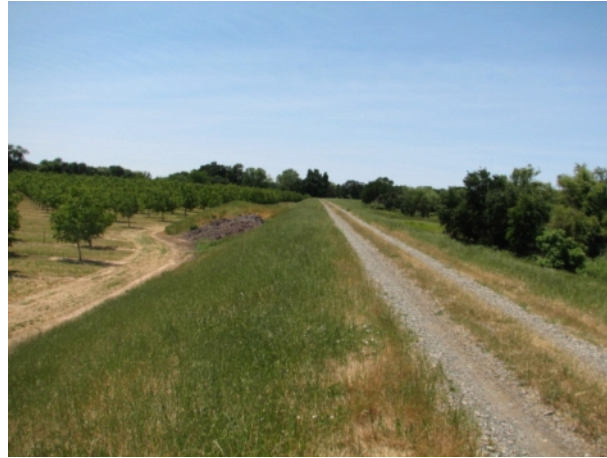
Levee Mile Report Line	1
Start Levee Mile	0.00
End Levee Mile	3.82
Location	Land Side
Category	Earthen Levee
Item	Vegetation

Levee mile 0.71, this is a photo of the vegetation on the landside slope.

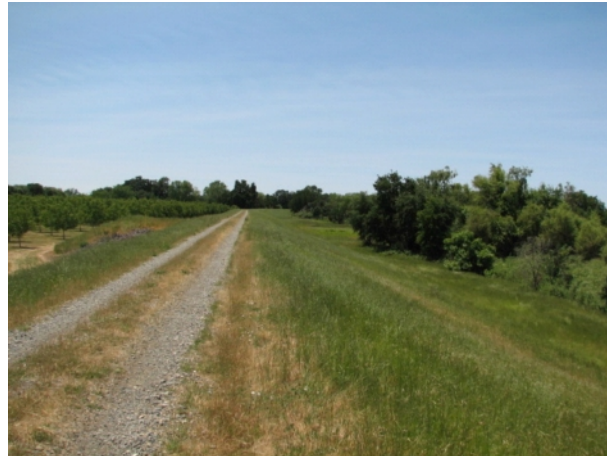
Levee Mile Report Line	2
Start Levee Mile	0.00
End Levee Mile	3.82
Location	Water Side
Category	Earthen Levee
Item	Vegetation

Levee mile 0.71, this is a photo of the vegetation on the waterside slope.

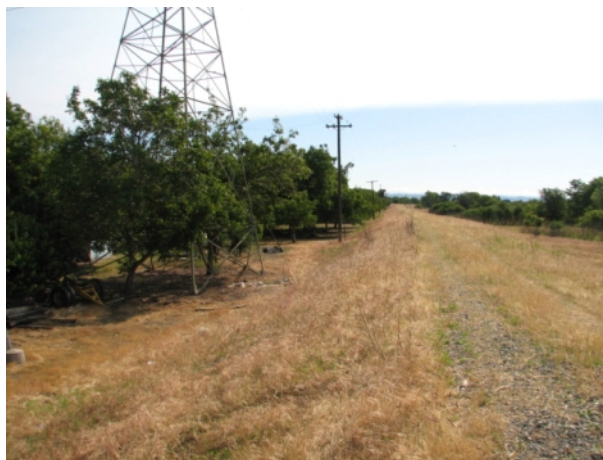
Levee Mile Report Line	1
Start Levee Mile	0.00
End Levee Mile	3.87
Location	Land Side
Category	Earthen Levee
Item	Vegetation

Levee mile 2.08, this photo shows the vegetation on the landside slope of the levee.

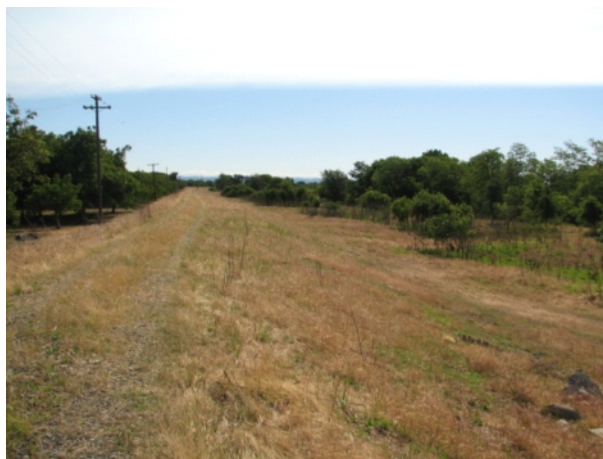
Levee Mile Report Line	2
Start Levee Mile	0.00
End Levee Mile	3.87
Location	Water Side
Category	Earthen Levee
Item	Vegetation

Levee mile 2.08, this photo shows the vegetation on the waterside slope of the levee.

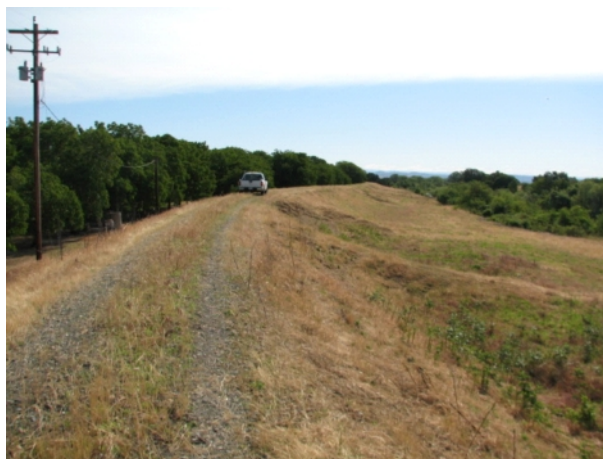
Levee Mile Report Line	9
Start Levee Mile	2.08
End Levee Mile	3.19
Location	Land Side
Category	Earthen Levee
Item	Slope Stability

Levee mile 2.08, this photo shows the slope is less than required, this is the downstream limit of the site, this is the waterside slope.

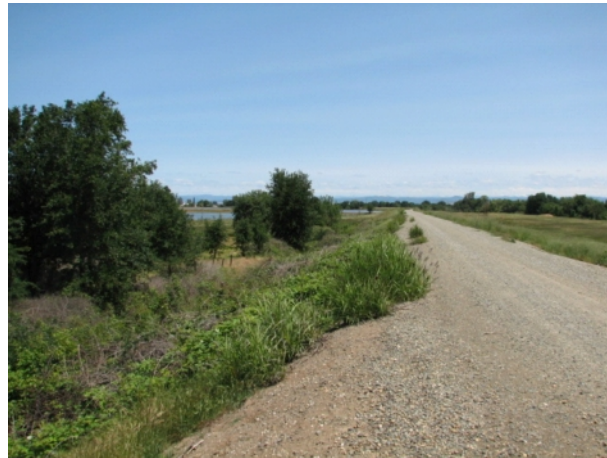
Levee Mile Report Line	1
Start Levee Mile	0.25
End Levee Mile	1.50
Location	Land Side
Category	Earthen Levee
Item	Vegetation

Levee mile 0.25, this is a photo of the vegetation on the landside slope.

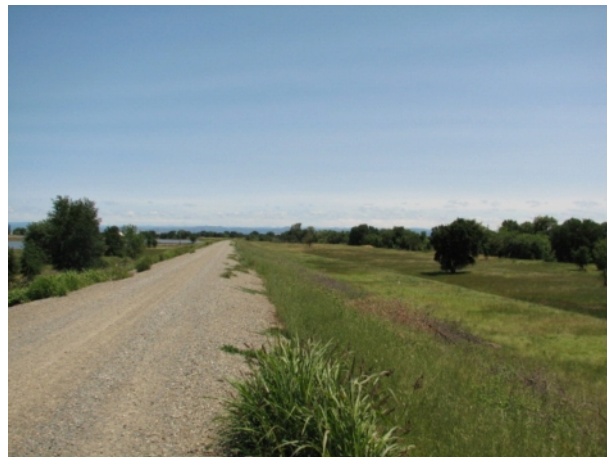
Levee Mile Report Line	2
Start Levee Mile	0.25
End Levee Mile	1.50
Location	Water Side
Category	Earthen Levee
Item	Vegetation

Levee mile 0.25, this is a photo of the vegetation on the waterside slope.

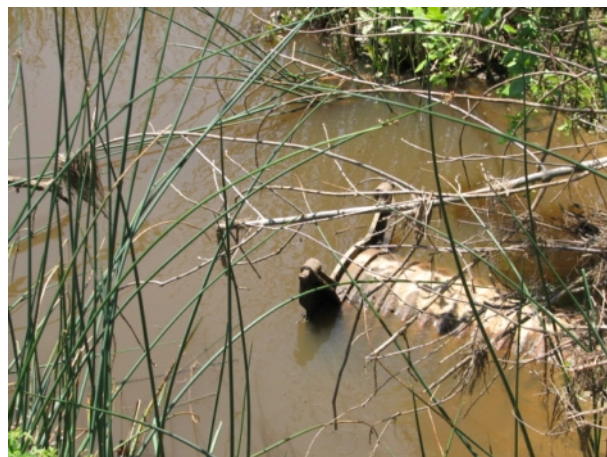
Levee Mile Report Line	5
Start Levee Mile	0.70
End Levee Mile	0.70
Location	Water Side
Category	Interior Drainage & Piping Systems
Item	Flap Gates

Levee mile 0.70, this is a photo of a missing flap gate at the waterside berm.

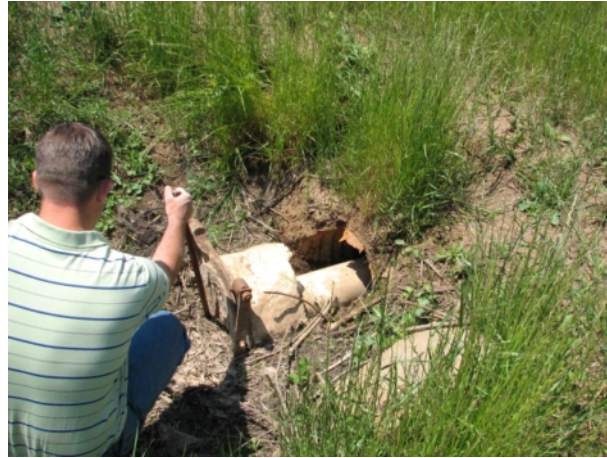
Levee Mile Report Line	8
Start Levee Mile	1.18
End Levee Mile	1.18
Location	Water Side
Category	Interior Drainage & Piping Systems
Item	Metal Pipes

Levee mile 1.18, this is a photo of a damaged pipe at the waterside berm.
